This giant carriage clock (10.5" high) with rack striking was made by Richard & Co, Paris & London circa 1903; this clock had been dropped at some time in the past and then poorly repaired. The clock needed a full service and extensive repairs to the platform escapement and movement as a whole.

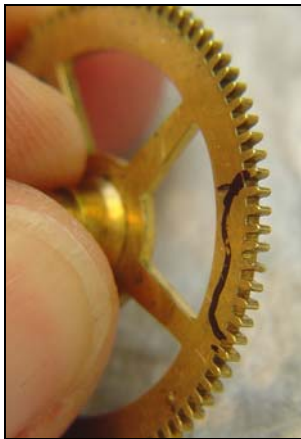
Damage to the hour wheel teeth caused by excessive pressure while trying to set the hands while the strike was locked? These were carefully straightened.

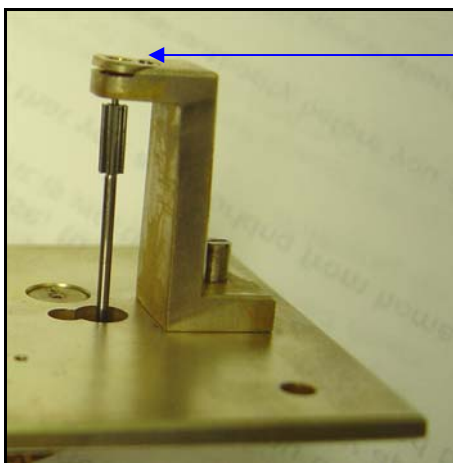
The top pivot was found to be very short, this had been damaged in the fall; the repairer had fitted a chaton type jewel to the top cock rather than re-pivot this arbor. This gave a better chance of utilising this very short and damaged pivot.

Other jewels on the platform were found to be cracked and also needed replacement.

I decided to remove the escape wheel from the arbor and remake it to the correct length. I spliced in a new end on the arbor and reformed the pivot and replaced the jewellery with a larger press in type.

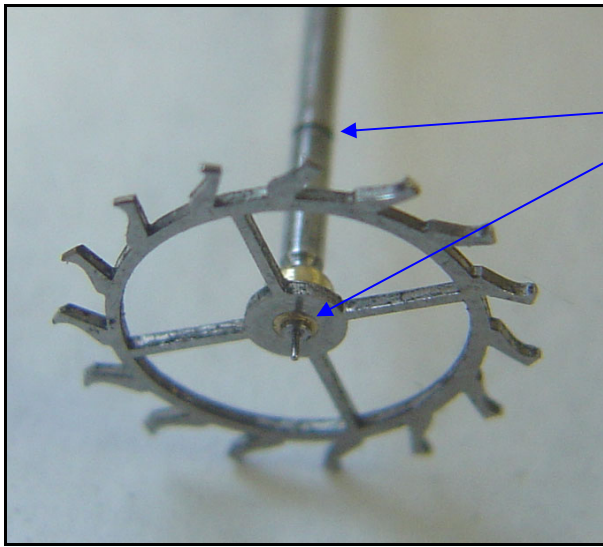
The end stone was not fitting correctly on the bottom cock as the wrong type of jewel had been fitted

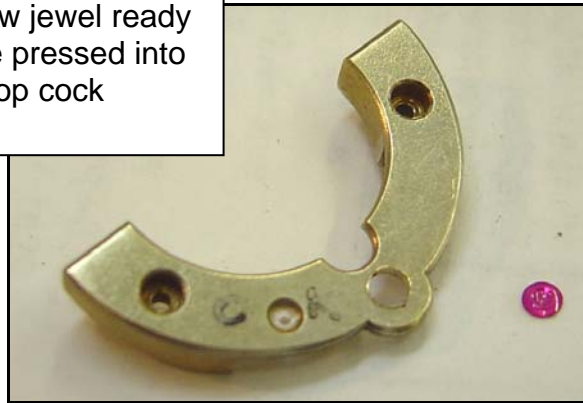
This picture shows the new end fitted to the escape wheel arbor and a new longer pivot

A new brass collet was made to hold the wheel

A new jewel ready to be pressed into the top cock

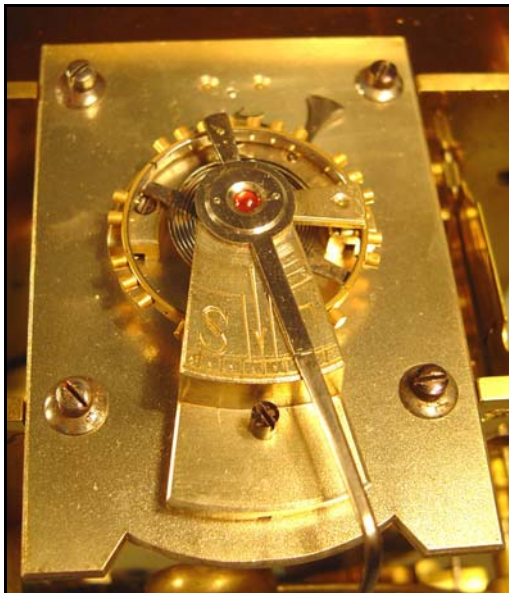
The reassembled platform escapement now back together

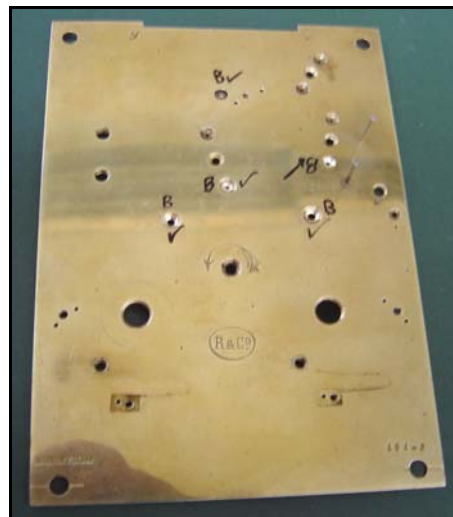
The back plate of the clock after fitting several new bushes

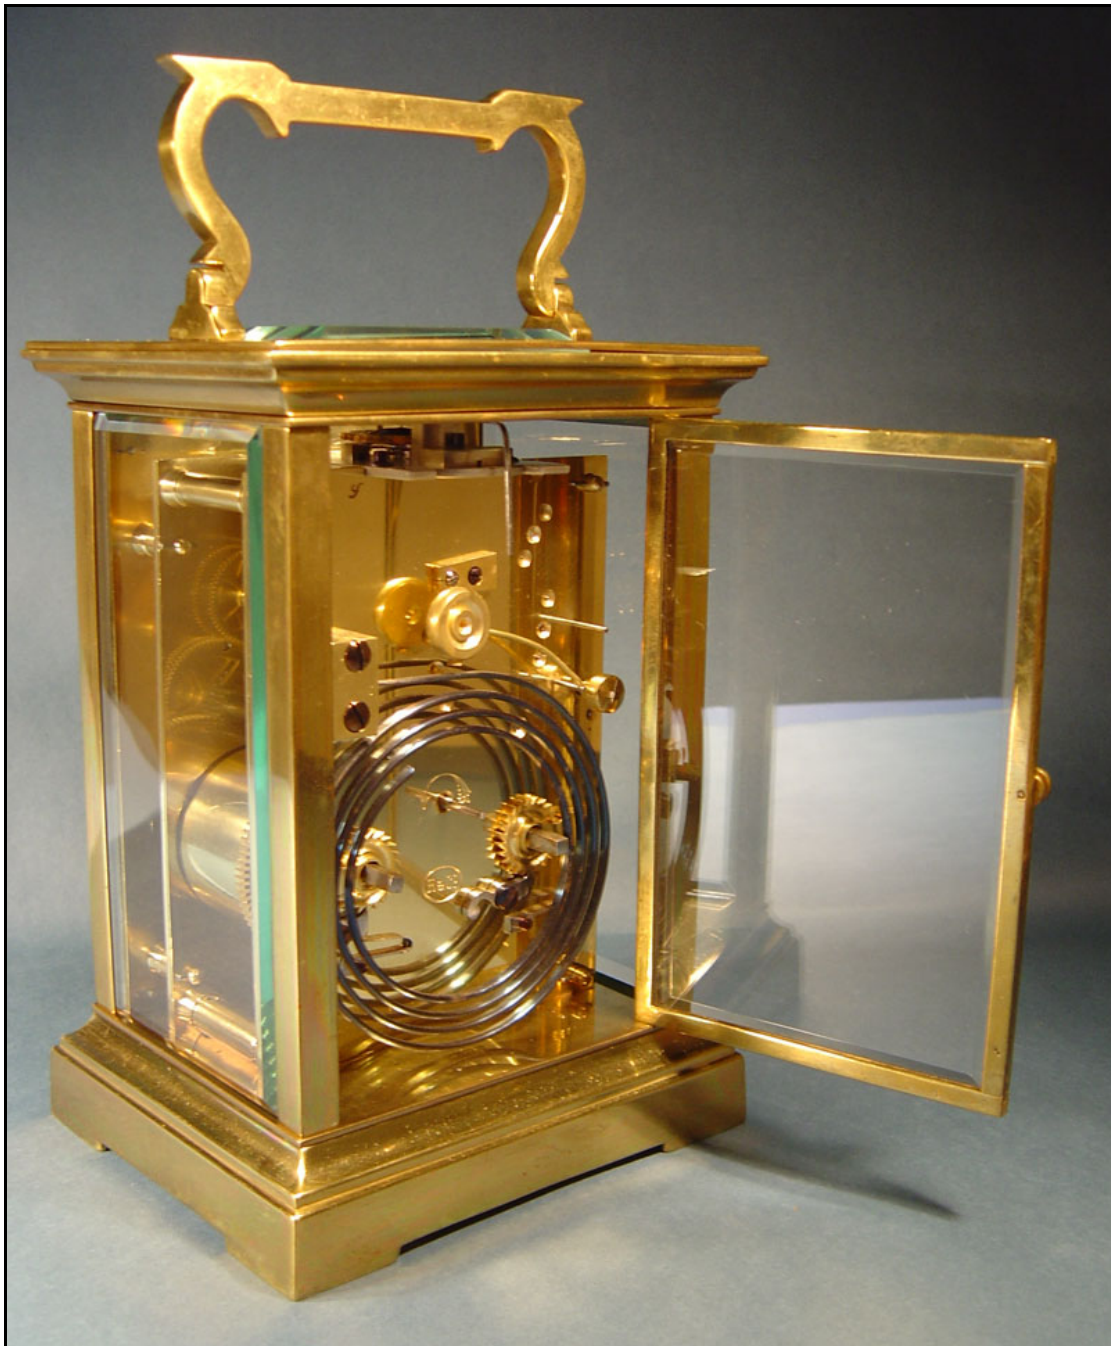
A back view of the Richard clock after the restoration work was completed. The clock had not seen much service work in its 100 year life but was now running well.
